SITE ASSESSMENT
FOR ENVIRONMENTAL CONSTRUCTION, INC.
NITRO CRANE AND RIGGING PROJECT
F/K/A KING RIVER LIMITED

May 23, 1994

RE: Site Assessment
Nitro Crane and Rigging
f/k/a King River Limited

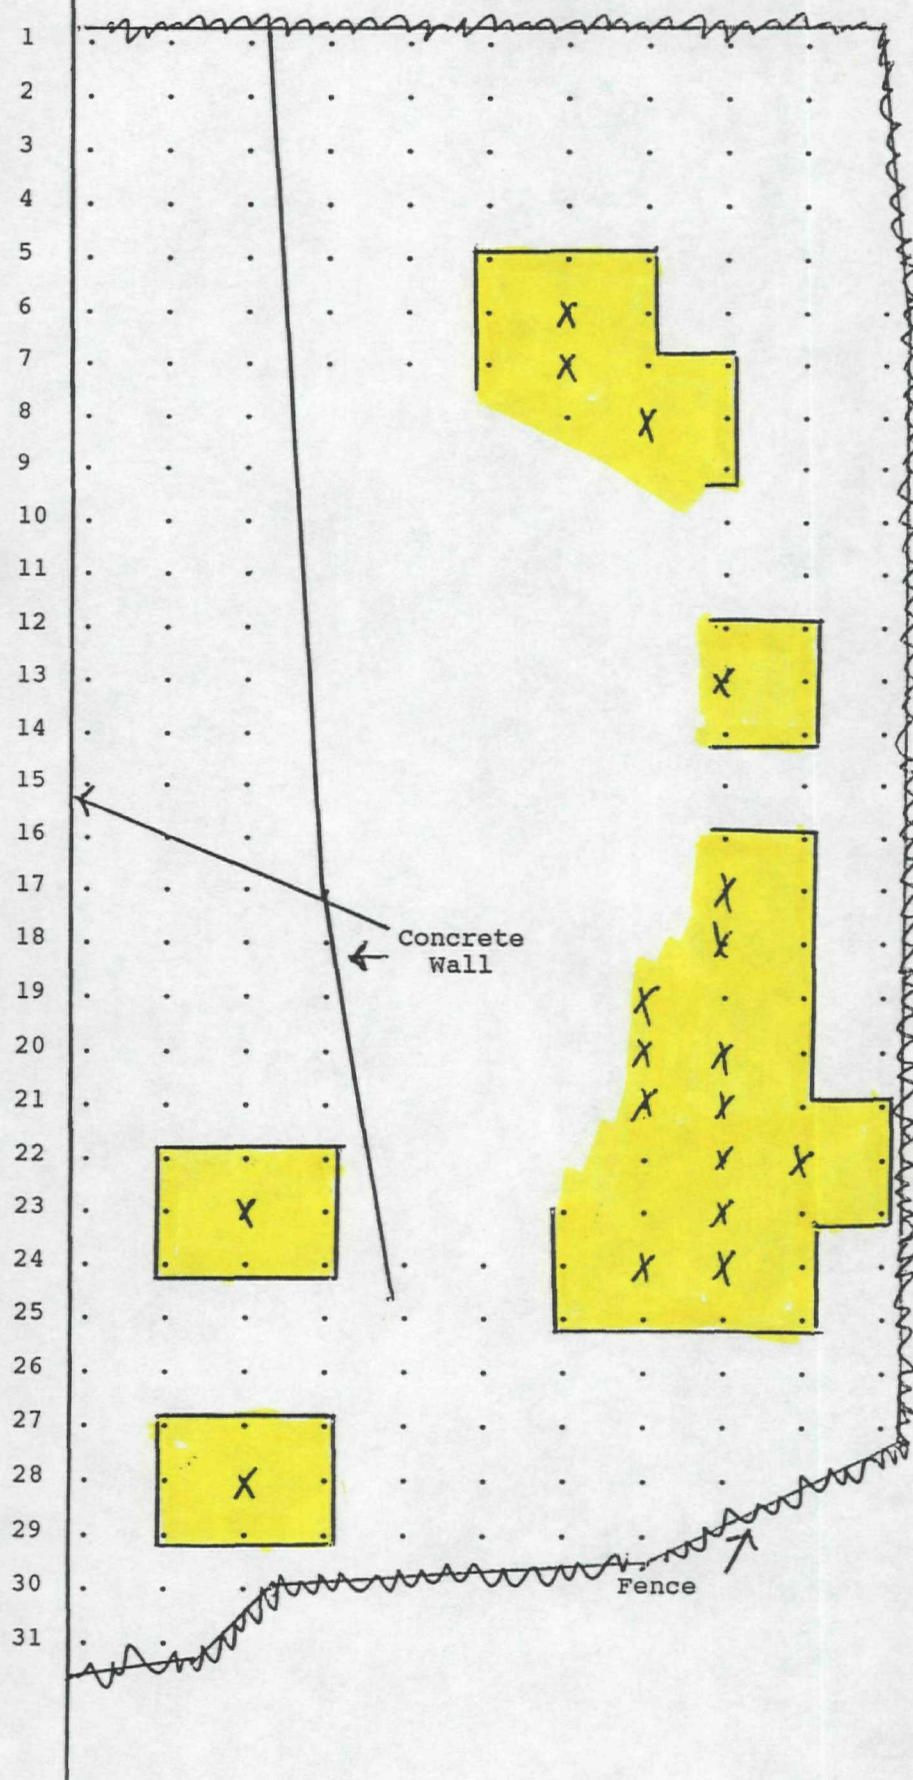
<u>Area</u>	<u># of samples taken</u>	<u># of samples over 25 ppm</u>	<u>location & number high sample 25 ppm+</u>	<u>location & number low sample 25 ppm+</u>
Upper platform	214	18	C-23, 650 ppm	J-22, 26 ppm
South wall	29	3	DSWV-16, 16000 ppm	DSWV-15, 40 ppm
West wall	2	0	NA	NA
North Wall	24	1	INWV-16, 45 ppm	NA
Floor Area	45	34	F-H-16, 16000 ppm	E-H-13, 28 ppm
Totals	314	56

All spill area #2 samples found to be 25 ppm or greater can be found inside the fenced in area as designated in the AOC.

Excavation began in the upper platform area of spill #2 on May 9, 1994 and is being reassessed after the first excavation.

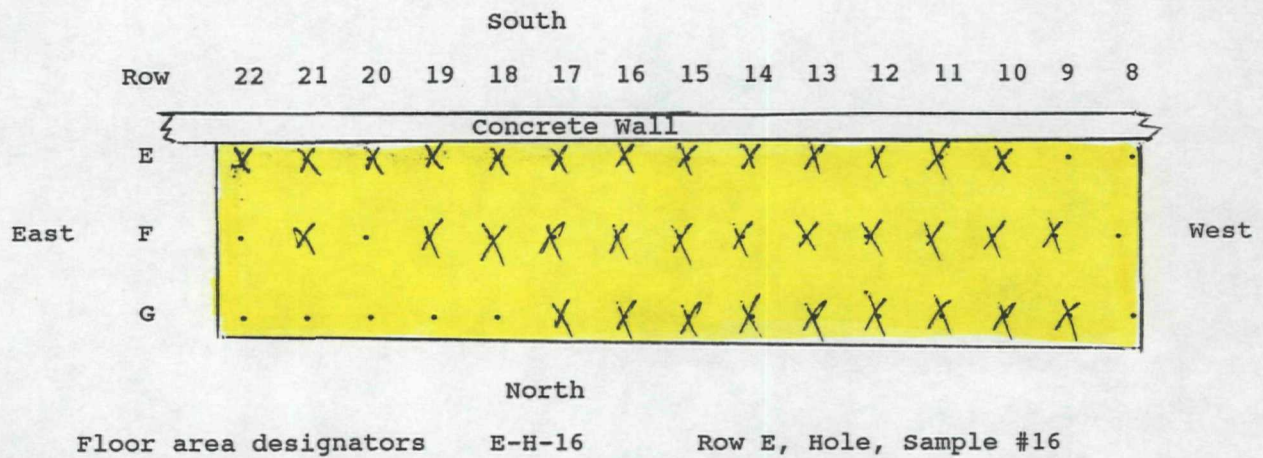
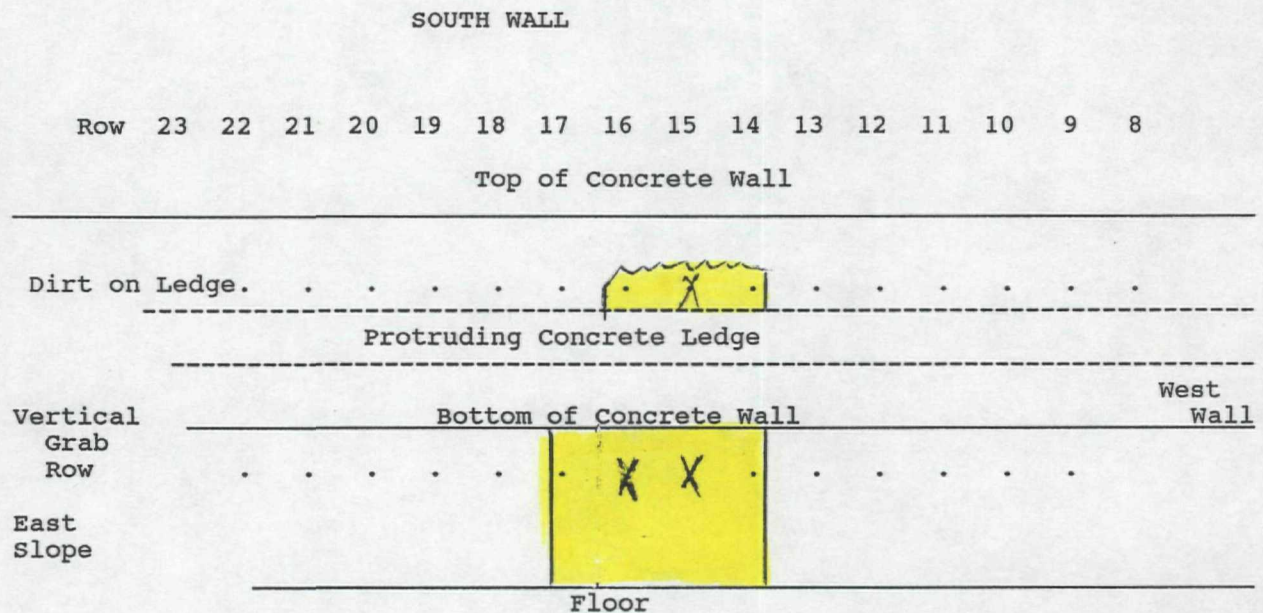
Floor Area of Spill #2

Sample DSWV 16 was recorded at 16000 ppm and is located directly under the vertical eroded plane, under the concrete wall.

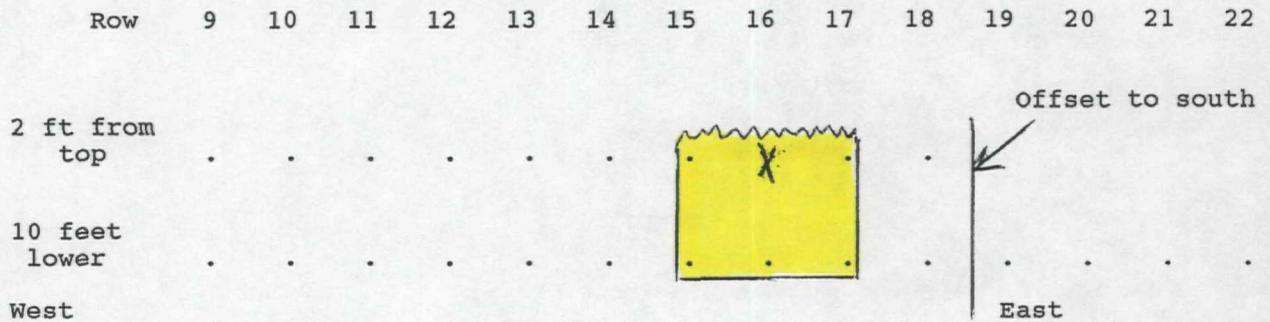
North Wall

Top Row	INWV-9	Row I, North Wall, Vertical, Sample #9
Lower Row	HNWV-9	Row H, North Wall, Vertical, Sample #9

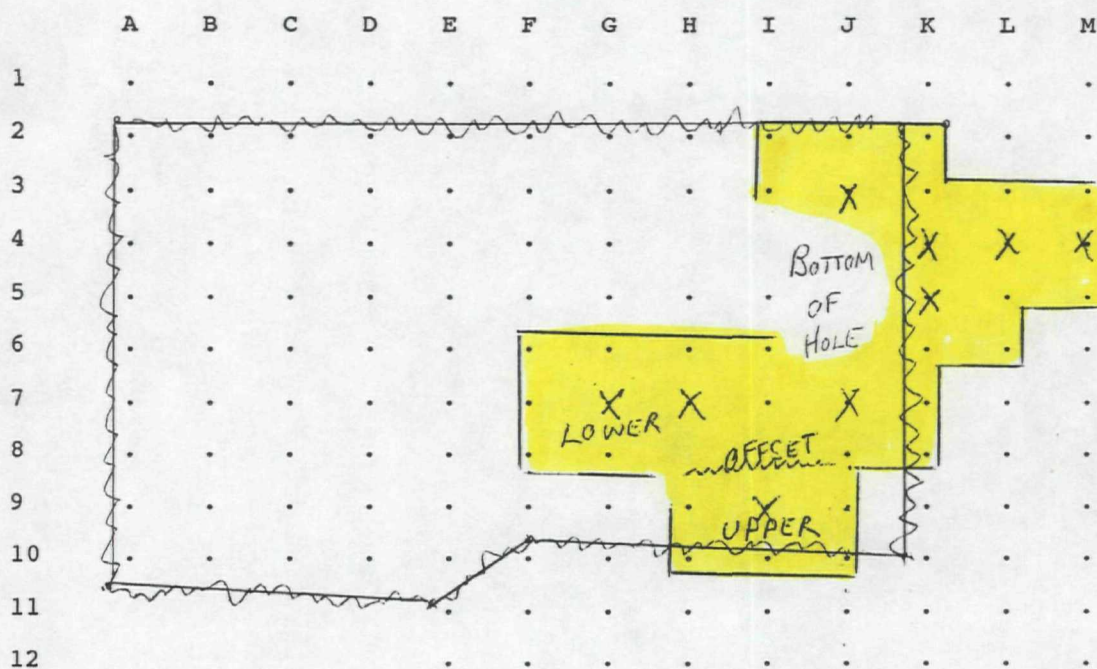
Spill Area #3 Upper Platform

<u>Area</u>	<u># of samples taken</u>	<u># of samples over 25 ppm</u>	<u>location & number high sample 25 ppm+</u>	<u>location & number low sample 25 ppm+</u>
Upper platform	141	9	K-5, 11000 ppm	J-7, 31 ppm
South wall	3	3	JSWV-2, 6600 ppm	JSWV-1, 4300 ppm
West wall	6	3	JWWV-1, 2900 ppm	JWWV-2, 39 ppm
East Wall	9	1	JV-3, 120 ppm	NA
Floor Area	4	0	NA	NA
Totals	163	16

Contaminated samples as high as 6200 ppm can be found as low as 30 ft. below the rim of the excavated area.

Excavation has not started in this area as of yet, as a heavy hammer would have to be mobilized accomplish the necessary cleanup requirements. This hammer represents a tremendous cost increase and will be mobilized only after areas #2 & #4 are completely excavated or are in need of a hammering device. This machine would be used for full time operations only and will then be demobilized as a cost saving measure.

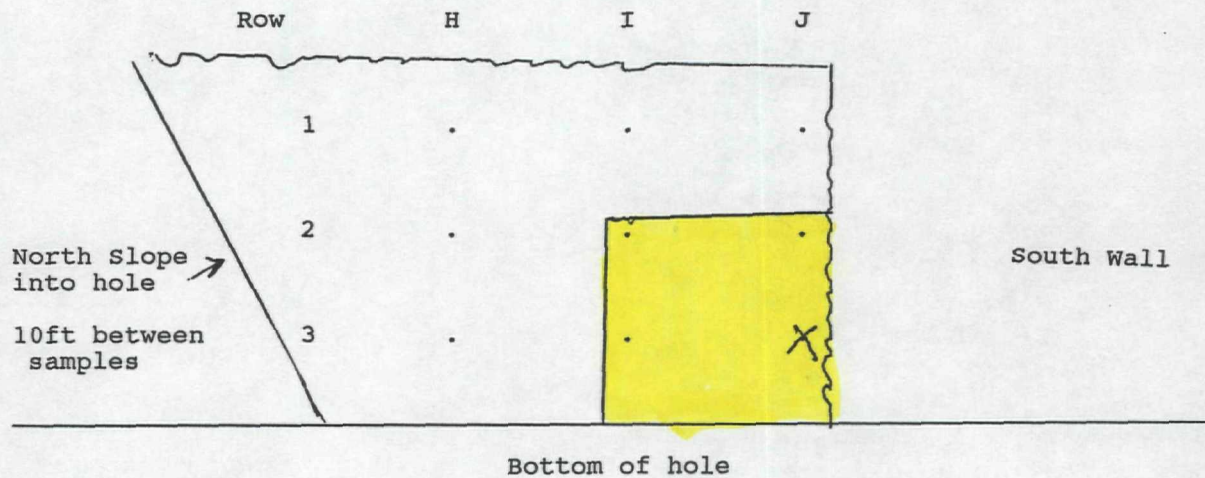
East wall

Sample Designators HV1- Row H, Vertical Sample, #1

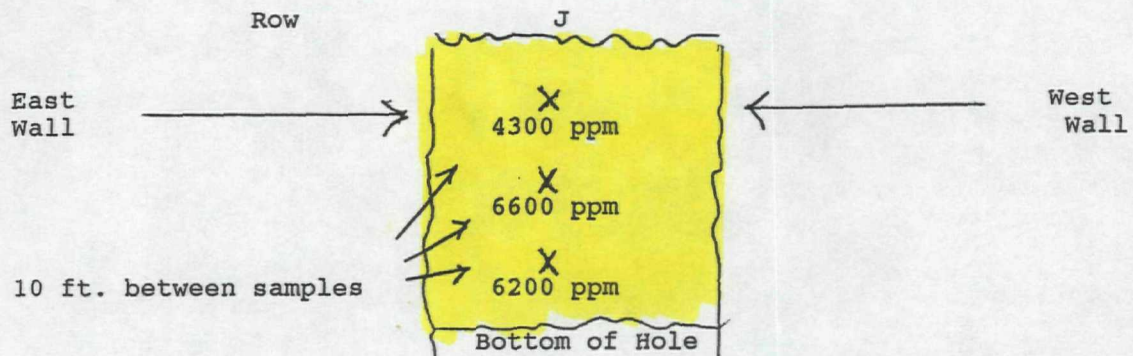
South Wall

Sample Designators JSWV1- Row J, South Wall, Vertical Sample #1

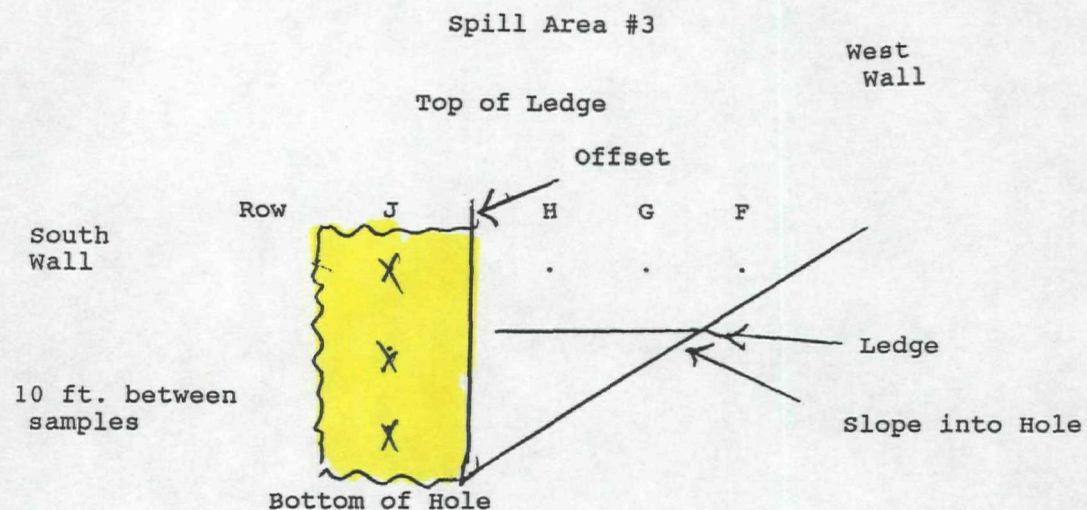
JWWV1- Row J, West Wall, Vertical Sample #1
HV8- Rows H,G,F Vertical Samples, Cross Row #8

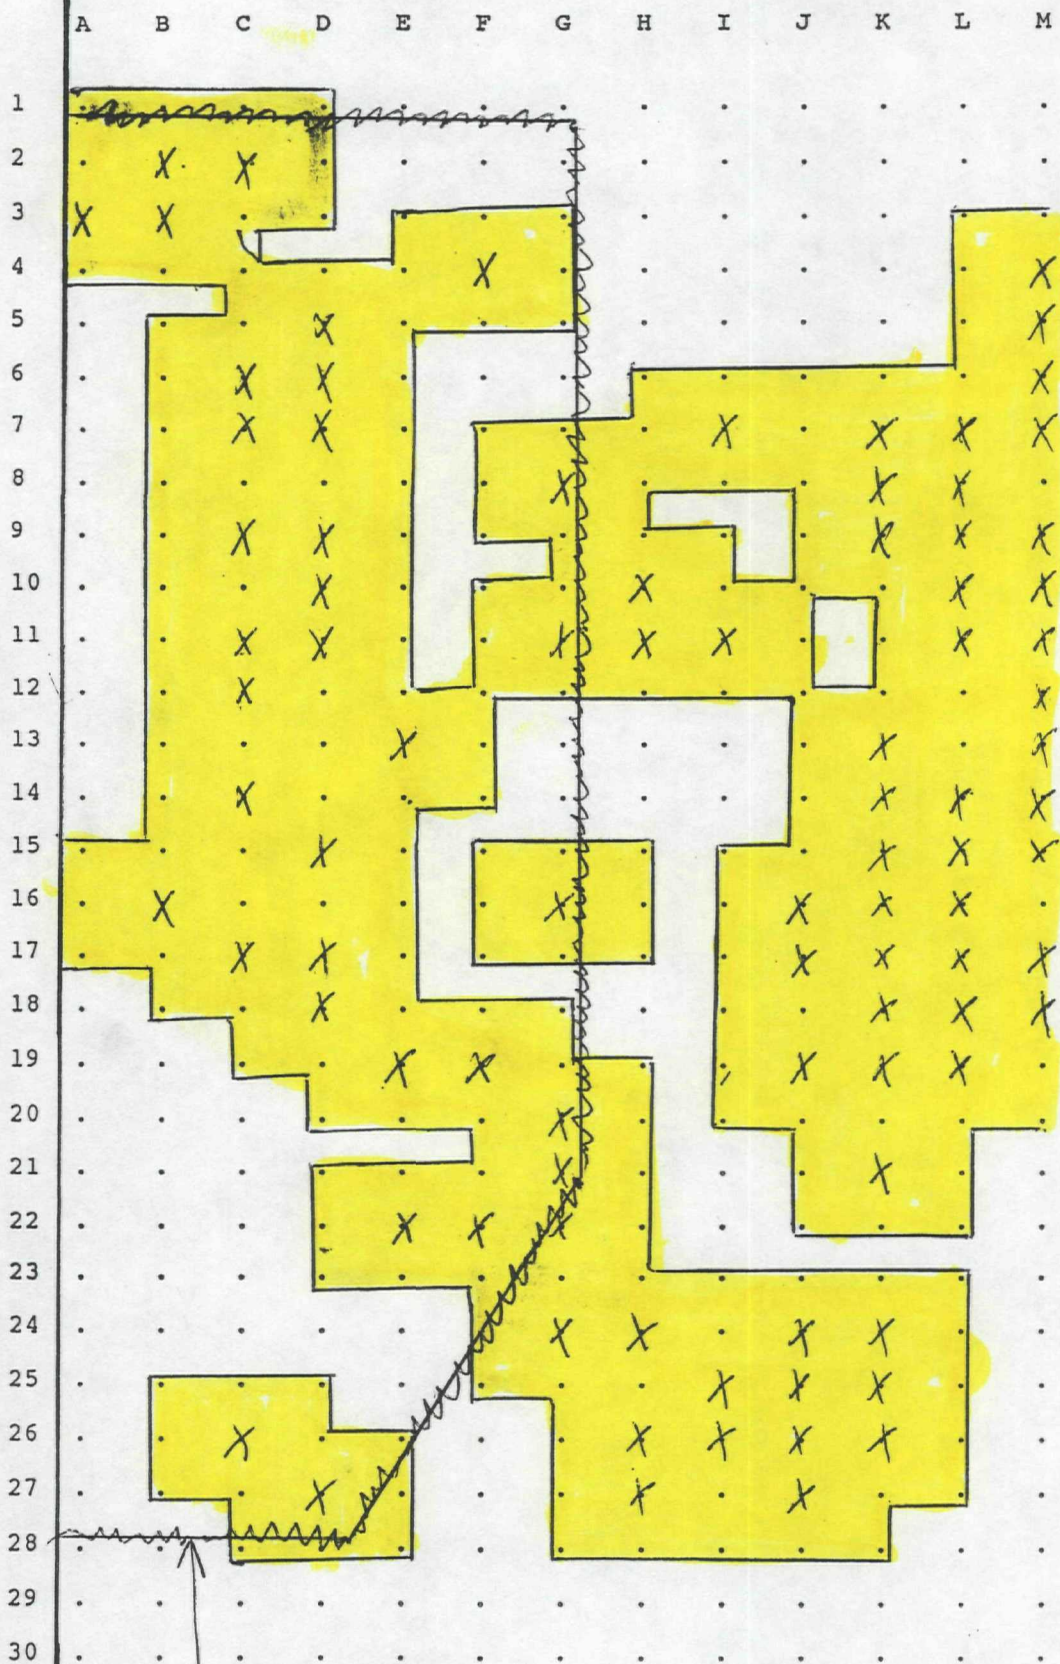
SPILL AREA # 4

<u>Area</u>	<u># of samples taken</u>	<u># of samples over 25 ppm</u>	<u>location & number high sample 25 ppm+</u>	<u>location & number low sample 25 ppm+</u>
Inside fence	171	34	B-2, 3000 ppm	E-13,G-8, 25ppm
Outside fence	219	56	H-24 1700 ppm	J-19,M-18 26ppm
Totals	390	90

During the course of assessment, it was discovered that more than one Arochlor was present on site other than Arochlor 1260. Several samples were recorded as having 1254 Arochlor, with 2 of the samples being recorded as being greater than 25 ppm.

Excavation began inside in fenced-in area of spill #4 on May 11, and excavation continues as of this date.
